Mary Jane & John Stair Farm
Silver Run (vicinity)

1891-1898

Maryland Historical Trust State Historic Sites Inventory Form

Survey No. CARR-1392

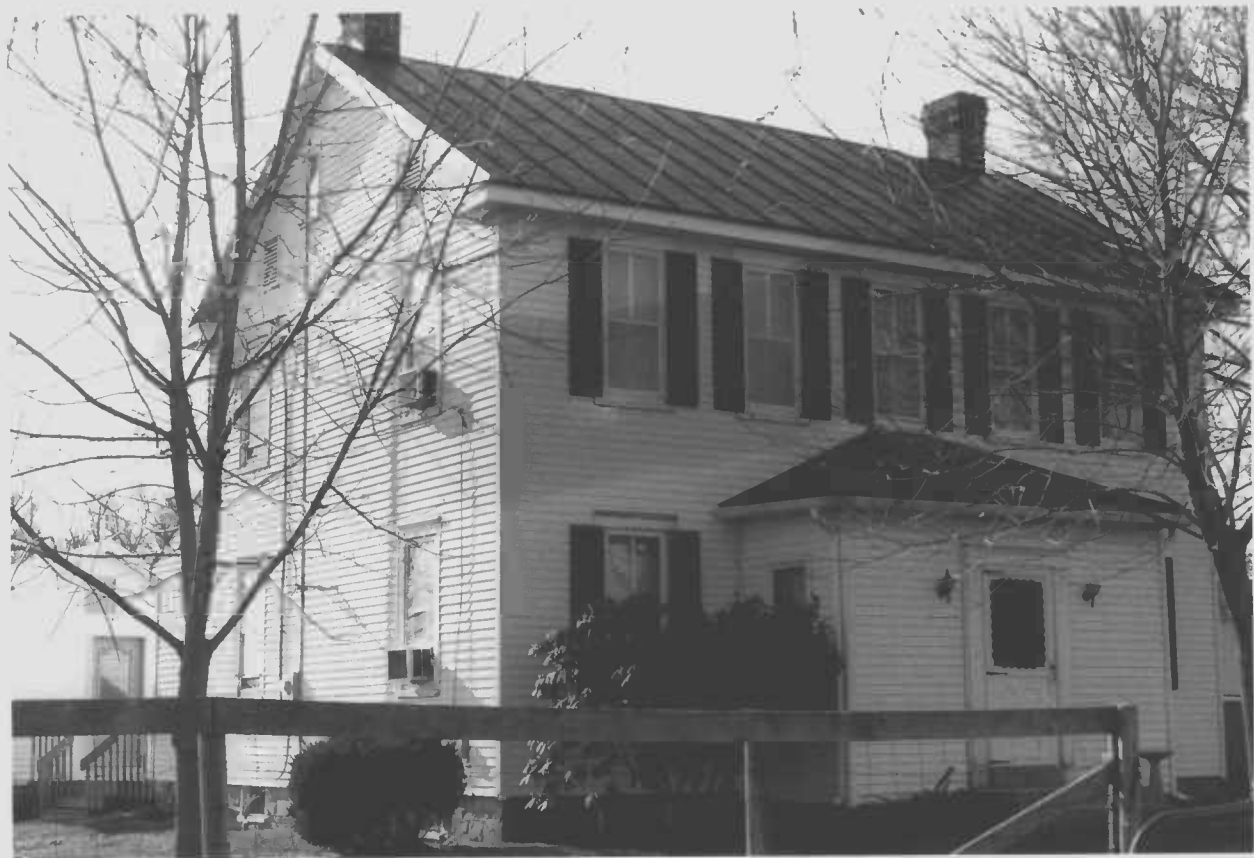
1/4

House - E & N elevations

The house faces north, and is a two-story, five-bay by two-bay structure. The house has a rubble stone foundation that is partly dressed and coursed, aluminum siding over top of German siding, a box cornice with returns, and a standing-seam metal gable roof with an east-west ridge. There is an interior brick chimney with a corbelled cap centered on the ridge of each gable end. The north elevation has a three-light sash in the east and west bays of the foundation. The first story is a modified Pennsylvania Farmhouse plan structure with a blank center bay flanked by two doors. There is an original three-bay, one-story, hipped-roof porch with asphalt shingles. It is now enclosed and has a center doorway. The original two doorways have a one-light transom and four-panel doors that have been cut in half to create double doors and were probably moved here from another location. They have sunk, fielded panels with small ogee panel moulds. The surrounds are plain, with the top trim lapping over the side trim. Flanking each side of the porch is a 2/2 double-hung sash with a wood sill and wood lintel with an ogee-moulded cornice. There are new, fake blinds, but old shutter hinges survive. The second story has five 2/2 sash.

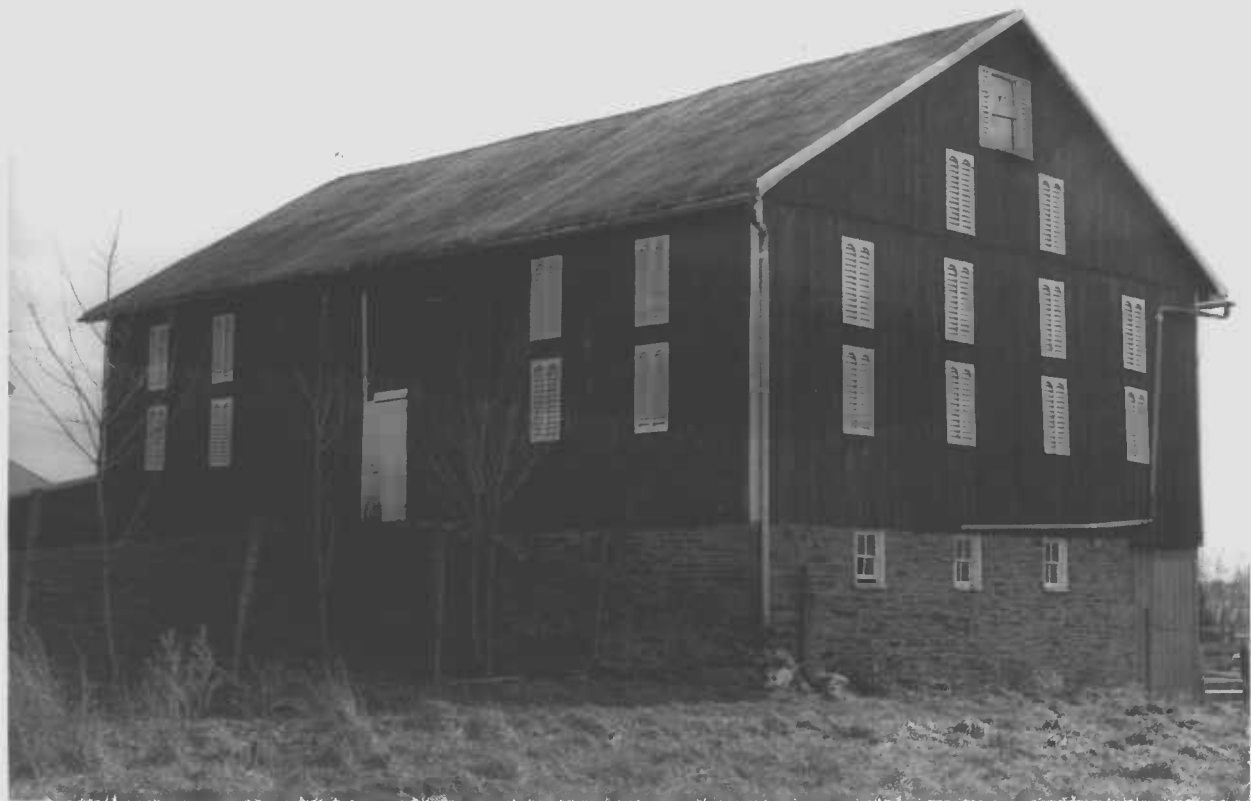
2/4

Barn - N & W elevations

The north elevation of the barn has a four-light wood sash in the east bay of the lower story. The upper story has central double wagon doors on strap hinges, with two vents over two vents on each side of the doors. On the west elevation, the lower story has three 2/2 wood sash with wood sills and mitered wood frames. The upper story matches that on the east, but there is no trim above the window and vent in the peak. There are two re-used doors on the CMU addition and alteration to the barn that may have been the original front doors of the house. They have four panels with bolelection panel mouldings that have bulls-eye corner blocks. There are chamfers cut on the edges of the rails and stiles next to the mouldings. The centers of the panels have three reeds, with the middle reed wider than the other two. The center rail of the door has two horizontal mouldings run on it. Each of these mouldings has a bead on the outer sides and a single bead in the center, with a Greek-profile ogee between each of the outer beads and the center bead.

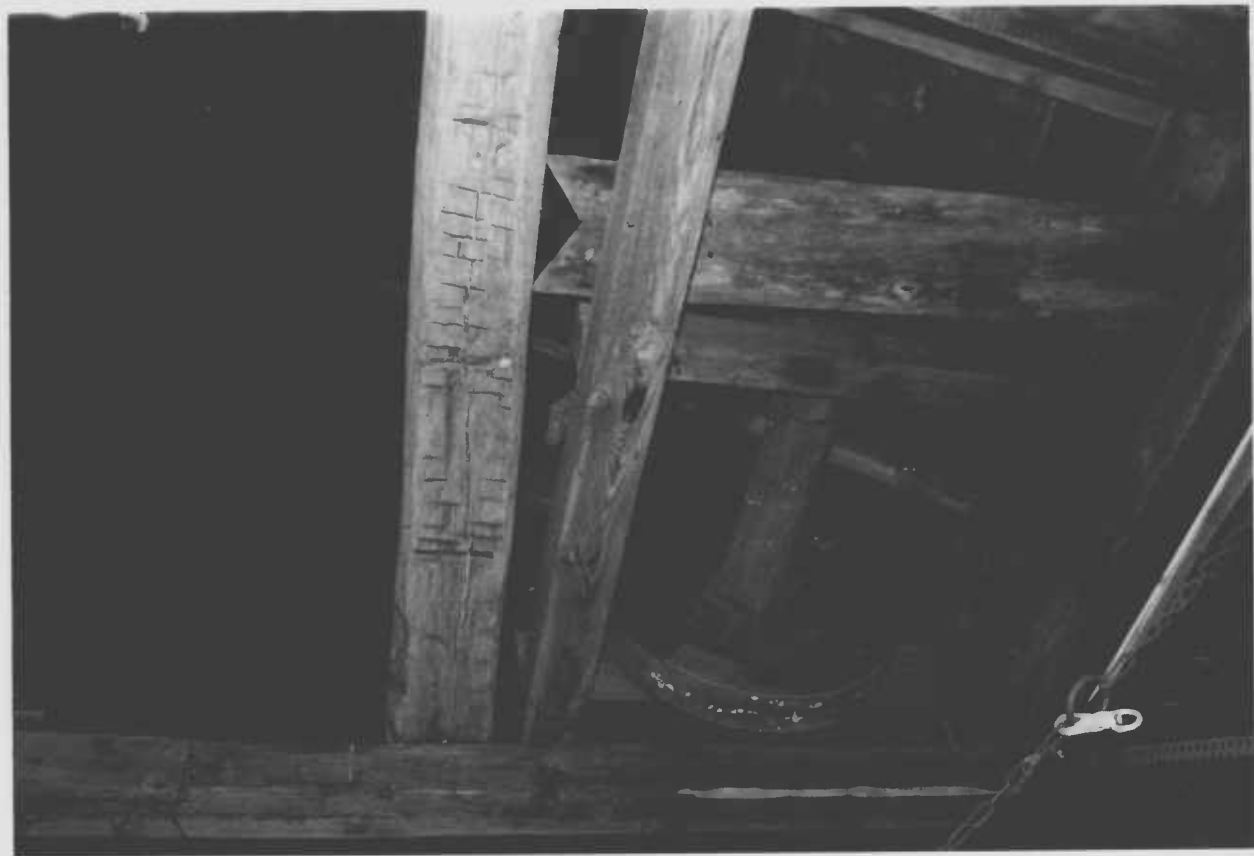
3/4

Neg. Loc.: Maryland Historical Trust
winch in barn

The upper story has a center threshing floor with a hay mow on each side and a granary in the southeast corner. The four bents are of hewn timbers with pegged mortise-and-tenon joints. Each bent has four posts, with a queen post truss to support the roof purlins. The rafters are sawn, are about $2\frac{1}{2} \times 4$ inches and are mitered at the ridge. They support sawn lath and wood shingles. Some of the frame work appears to be re-used timbers. Over the threshing floor is a windlass with a wood axle and a large wood wheel about 3 feet in diameter attached to it. There is a hole in the board wall of the threshing floor, near the floor, and painted above it is "WEIS & HALL Williamsport, PA". There is a metal rod with three different size wood wheels on it that is no longer in situ, but apparently was connected to the hole in the wall. This device reportedly had a rope from the large wheel to the smaller ones, and was used to haul wagons into the threshing floor because horses could not turn around in there.

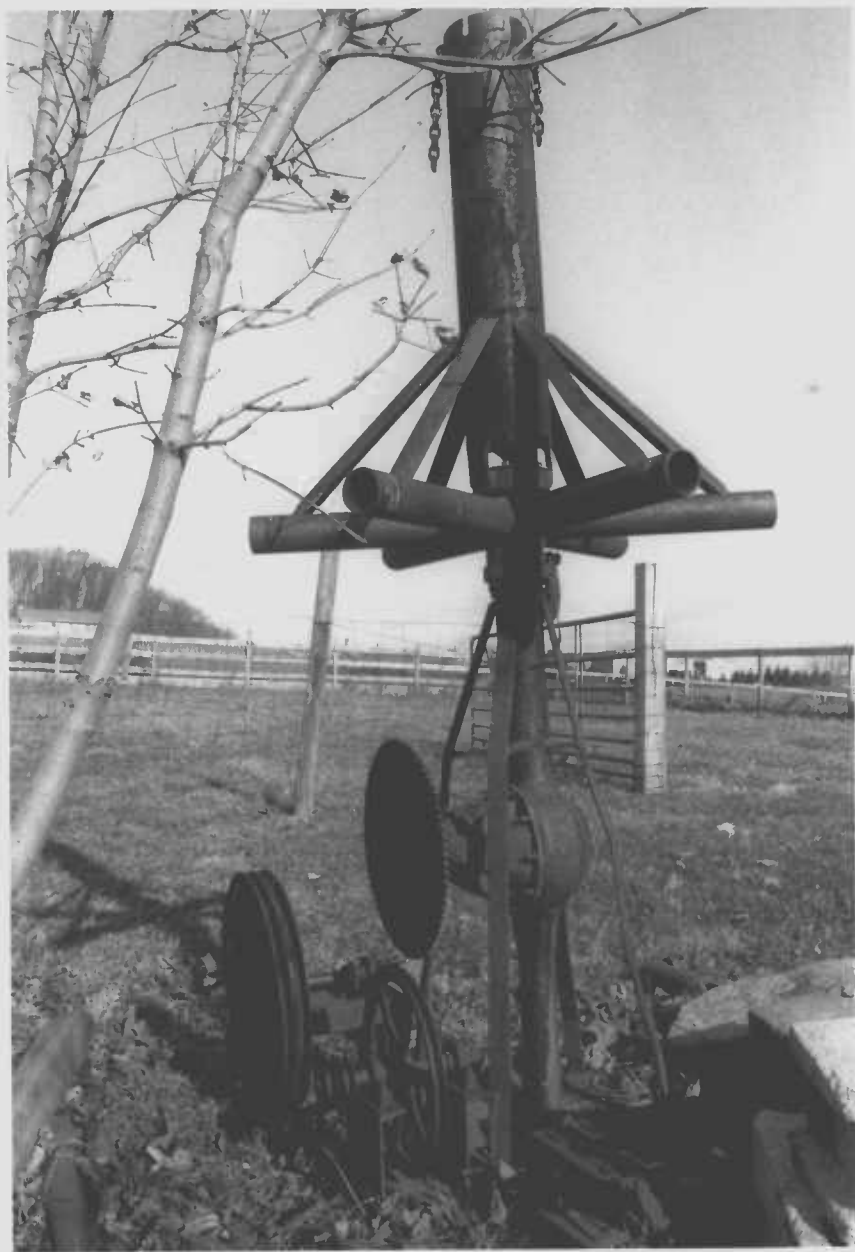
4/4

Horsepower ?
